DUBLIN AIRPORT NORTH RUNWAY DEVELOPMENT

MATERIAL MANAGEMENT DESIGN REPORT FOR THE MANAGEMENT FOR PFOS/PFOA IMPACTED SOILS

Prepared for: Roadbridge FCC Joint Venture

Date: November 2020

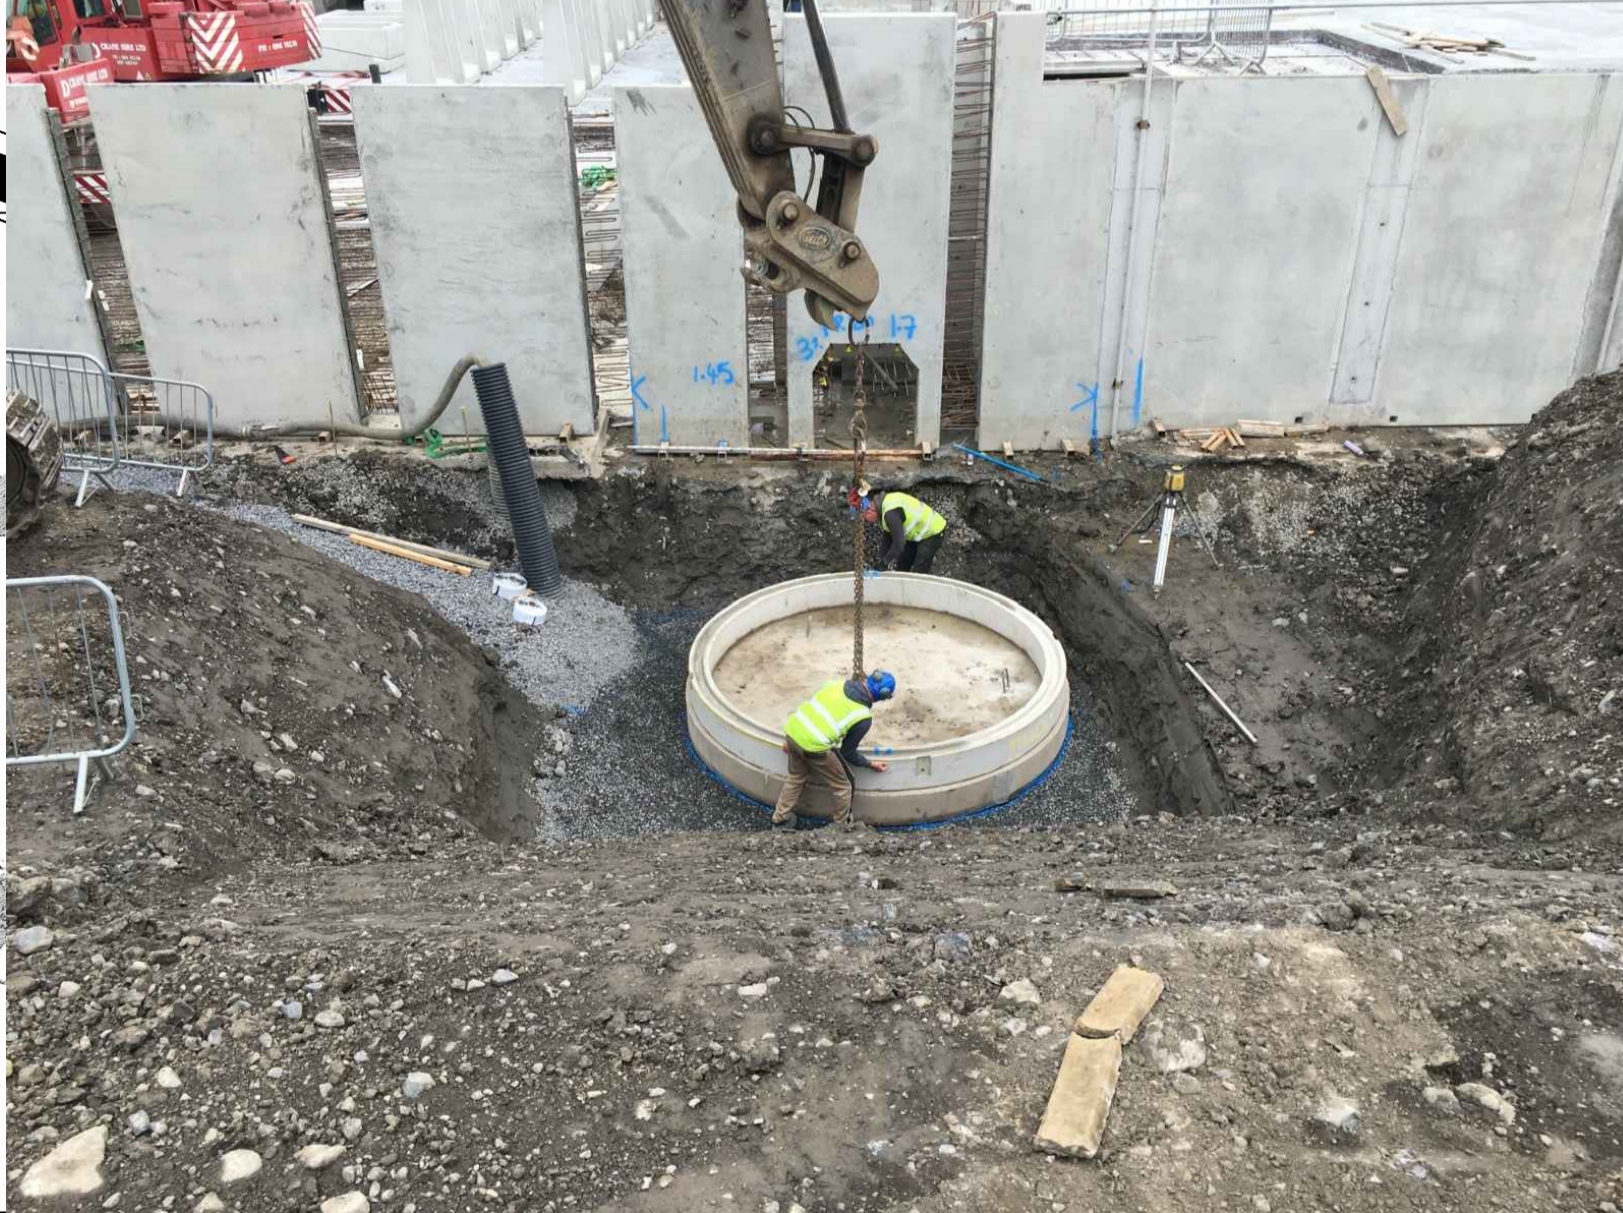
Structure location showing 2.0m depth of Dublin Boulder Clay
